**Flood Control Project Maintenance
Levee Inspections**
LMA District Cover Sheet
Spring 2018 Levee Inspection Results

Reclamation District No. 2060 Hastings

Spring 2018 Levee Inspection Results

Waterway			Bank	Unit Miles
Unit No. 01 Lindsey Slough			Left	6.97
	Spring (March - May)	Summer (June - August)	(September - November) Fall	Winter (December - February)
Unit Maintenance Rating (Fall Only)				
Date of Inspection	3/28/2018 - 3/28/2018			
DWR Inspector	Keith Millard			
Accompanied By	Mark Boyd RD 2060 Hastings Tract			
	Michael Moncrief MBK Engineers			
	Jack Kuechler RD 2060

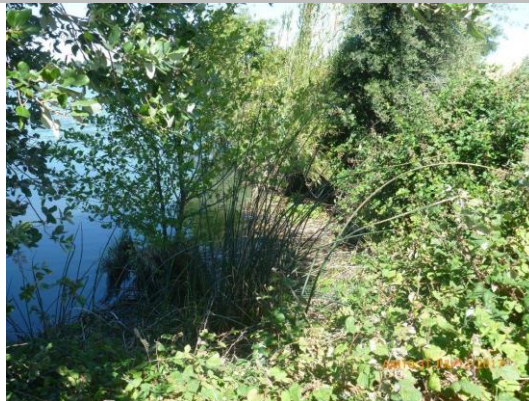
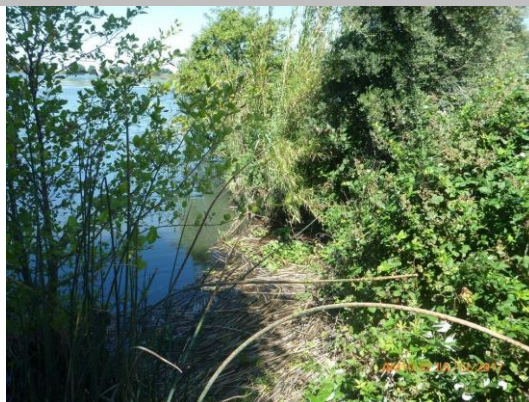
Photo 2 of 6 : SP_2018_RD2060_241_5_20180305_00002.jpg

LM Start	0.40	Rating **	M	Issue No.	5 (cont)	
LM End	0.40	Issue Type +	Ma	Location *		
Category	Supplemental			GPS Latitude/Longitude		
				Start	End	
Item	2017 Storm Damage			38.247894 °	38.247911 °	
				-121.703492 °	-121.703539 °	
DWR ID	DWR_RD2060_01_f _ 2017_5					
Comment Code						
Inspector Comment						
Levee Evaluation Comments						
Description:Erosion commences approximately 3/4 of the way down the slope, near the water line towards the waterside toe.						
Site ID No:358						
Site Designation:LMA-185						
Repair Type: Erosion						
Rating:Area of Concern						
Field Date:7/12/2017						
Notes: Small erosion into bank.

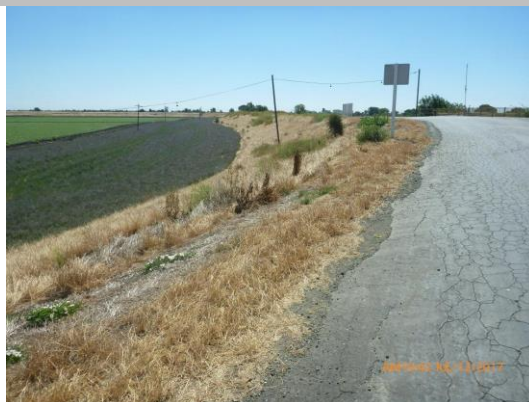
Photo 5 of 6 : SP_2018_RD2060_241_5_20180305_00005.jpg

LM Start	0.40	Rating **	M	Issue No.	5 (cont)	
LM End	0.40	Issue Type +	Ma	Location *		
Category	Supplemental			GPS Latitude/Longitude		
				Start		End
Item	2017 Storm Damage			38.247894 °		38.247911 °
				-121.703492 °		-121.703539 °
DWR ID	DWR_RD2060_01_f _ 2017_5					
Comment Code						
Inspector Comment						
Levee Evaluation Comments						
Description:Erosion commences approximately 3/4 of the way down the slope, near the water line towards the waterside toe.						
Site ID No:358						
Site Designation:LMA-185						
Repair Type: Erosion						
Rating:Area of Concern						
Field Date:7/12/2017						
Notes: Small erosion into bank.

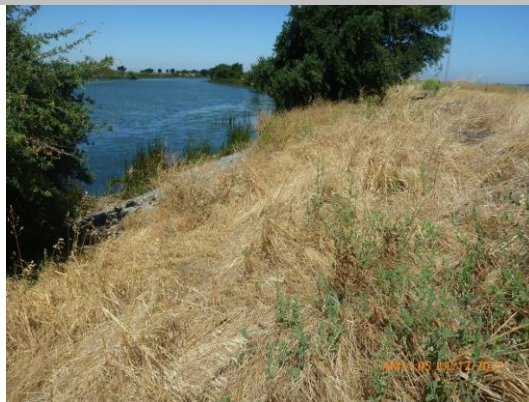
Photo 3 of 3 : SP_2018_RD2060_241_8_20180305_00009.jpg

LM Start	0.41	Rating **	M	Issue No.	8 (cont)	
LM End	0.42	Issue Type +	Ma	Location *		
Category	Supplemental			GPS Latitude/Longitude		
				Start	End	
Item	2017 Storm Damage			38.248036°	38.248017°	
				-121.703539°	-121.703789°	
DWR ID	DWR_RD2060_01_f_2017_8					
Comment Code						
Inspector Comment						
Levee Evaluation Comments						
Description:Erosion commences approximately halfway down the water side slope extending in to existing rip rap. Existing rip rap appears to have been pulled off in this section.						
Site ID No:359						
Site Designation:LMA-186						
Repair Type: Erosion						
Rating:Area of Concern						
Field Date:7/12/2017						
Notes: Site had riprap but is eroded away. Minor erosion in toe of levee.

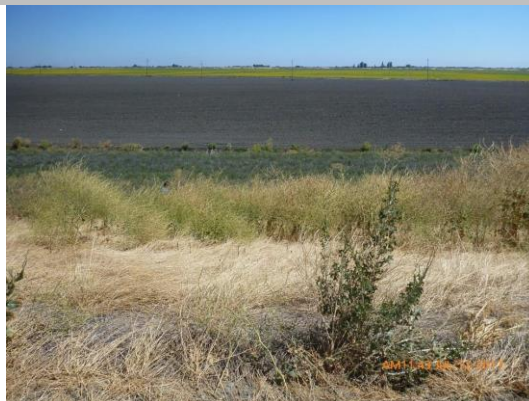
Photo 2 of 3 : SP_2018_RD2060_241_9_20180305_00011.jpg

LM Start	0.75	Rating **	M	Issue No.	9	
LM End	0.76	Issue Type +	Ma	Location *		
Category	Supplemental			GPS Latitude/Longitude		
				Start	End	
Item	2017 Storm Damage			38.249314 °	38.249400 °	
				-121.709461 °	-121.709608 °	
DWR ID	DWR_RD2060_01_f_2017_9					
Comment Code						
Inspector Comment						
Levee Evaluation Comments						
Description:Erosion commences approximately halfway down the water side slope extending in to existing rip rap. Erosion is concentrated near the waterline. Existing rip rap appears to have been pulled off in this section.						
Site ID No:360						
Site Designation:LMA-187						
Repair Type: Erosion						
Rating:Area of Concern						
Field Date:7/12/2017						
Notes: Erosion looks old but has progressed this year.

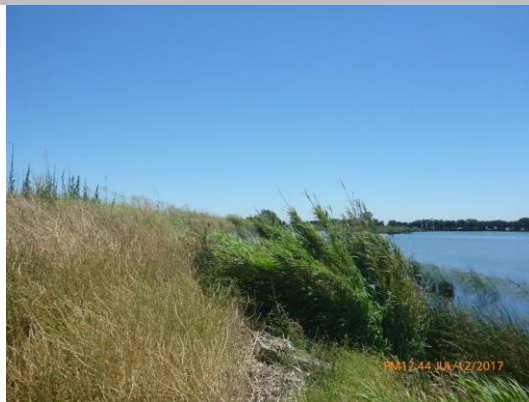
Photo 3 of 4 : SP_2018_RD2060_241_10_20180305_00015.jpg

LM Start	0.92	Rating **	M	Issue No.	10 (cont)
LM End	0.93	Issue Type +	Ma	Location *	
Category	Supplemental			GPS Latitude/Longitude	
				Start	End
Item	2017 Storm Damage			38.250875 °	38.250953 °
				-121.711942 °	-121.712078 °
DWR ID	DWR_RD2060_01_f_2017_10				
Comment Code					
Inspector Comment					
Levee Evaluation Comments					
Description:Sloughing commences approximately halfway down the water side slope.					
Site ID No:361					
Site Designation:LMA-188					
Repair Type: Erosion					
Rating:Area of Concern					
Field Date:7/12/2017					
Notes: Minor sloughing, mostly riprap has moved down the slope and into channel.

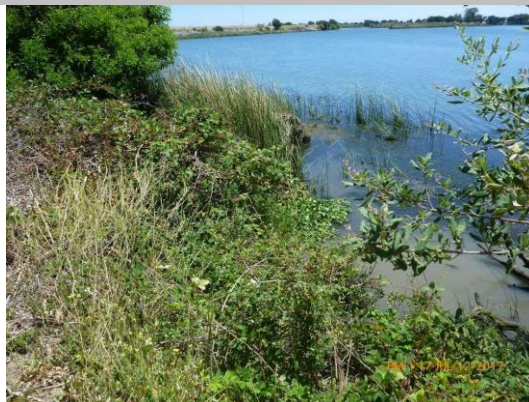
Photo 3 of 3 : SP_2018_RD2060_241_15_20180305_00019.jpg

LM Start	1.04	Rating **	M	Issue No.	15 (cont)
LM End	1.08	Issue Type +	Ma	Location *	
Category	Supplemental			GPS Latitude/Longitude	
				Start	End
Item	2017 Storm Damage			38.251058 °	38.250872 °
				-121.714050 °	-121.714792 °
DWR ID	DWR_RD2060_01_f_2017_15				
Comment Code					
Inspector Comment					
Levee Evaluation Comments					
Description:Erosion commences approximately 3/4 of the way down the water side slope concentrated at the waterline.					
Site ID No:362					
Site Designation:LMA-189					
Repair Type: Erosion					
Rating:Area of Concern					
Field Date:7/12/2017					
Notes: Erosion due to lack of revetment. Erosion ends at riprap downstream. Vertical cut at summer wse.

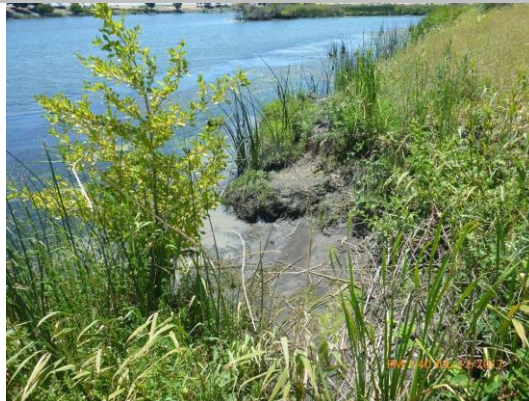
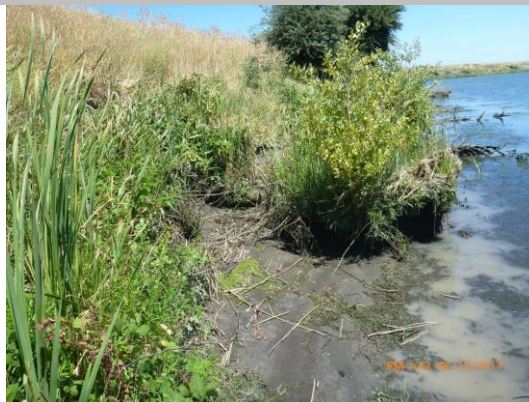
Photo 1 of 3 : SP_2018_RD2060_241_16_20180305_00020.jpg

LM Start	1.09	Rating **	M	Issue No.	16
LM End	1.10	Issue Type +	Ma	Location *	
Category	Supplemental			GPS Latitude/Longitude	
				Start	End
Item	2017 Storm Damage			38.250844 °	38.250833 °
				-121.714944 °	-121.714994 °
DWR ID	DWR_RD2060_01_f_2017_16				
Comment Code					
Inspector Comment					
Levee Evaluation Comments					
Description:Erosion commences approximately halfway down the water side slope extending to the toe.					
Site ID No:363					
Site Designation:LMA-190					
Repair Type: Erosion					
Rating:Area of Concern					
Field Date:7/12/2017					
Notes: Small erosion up to high water line. Cuts into slope with 6' vertical cut.

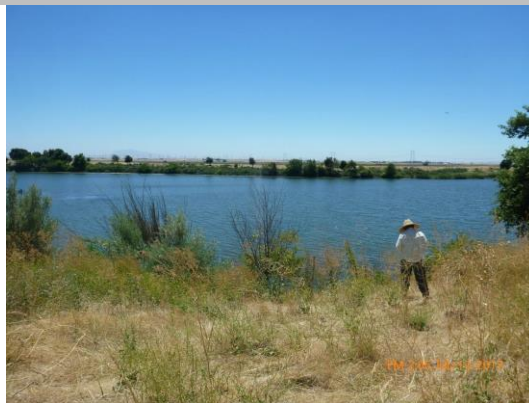
Photo 3 of 3 : SP_2018_RD2060_241_17_20180305_00025.jpg

LM Start	1.22	Rating **	A/W	Issue No.	17 (cont)	
LM End	1.23	Issue Type +	Ma	Location *		
Category	Supplemental			GPS Latitude/Longitude		
				Start	End	
Item	2017 Storm Damage			38.251186°	38.251289°	
				-121.717114°	-121.717264°	
DWR ID	DWR_RD2060_01_f_2017_17					
Comment Code						
Inspector Comment						
Levee Evaluation Comments						
Description:Erosion commences approximately 1/4 of the way down the water side slope extending to the toe.						
Site ID No:364						
Site Designation:LMA-191						
Repair Type: Erosion						
Rating:Critical						
Field Date:7/12/2017						
Notes: Very deep erosion that extends halfway into slope. Intact riprap on both sdes of erosion. Rated serious but could be critical if erosion cuts deep into prism.

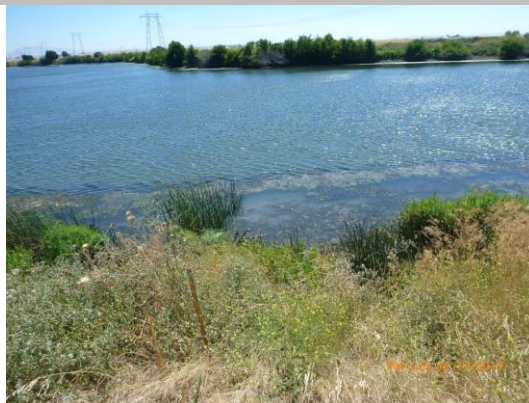
Photo 3 of 3 : SP_2018_RD2060_241_21_20180305_00031.jpg

LM Start	1.81	Rating **	A/W	Issue No.	21 (cont)
LM End	1.84	Issue Type +	Ma	Location *	
Category	Supplemental			GPS Latitude/Longitude	
				Start	End
Item	2017 Storm Damage			38.255972 °	38.256247 °
				-121.724197 °	-121.724464 °
DWR ID	DWR_RD2060_01_f_2017_21				
Comment Code					
Inspector Comment					
Levee Evaluation Comments					
Description:Erosion commences approximately halfway down the water side slope extending to the toe. Some slipping into the toe has occurred due to deep erosion.					
Site ID No:366					
Site Designation:LMA-193					
Repair Type: Erosion					
Rating:Serious					
Field Date:7/12/2017					
Notes: Erosion extends halfway into the slope.

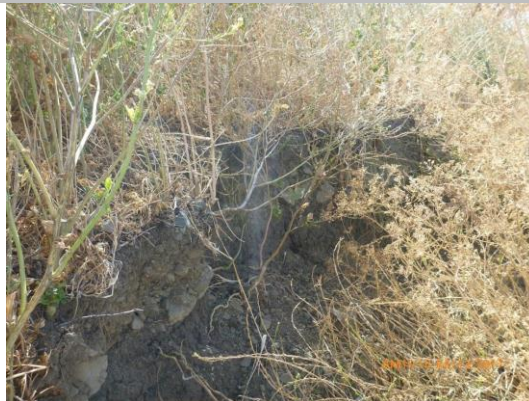
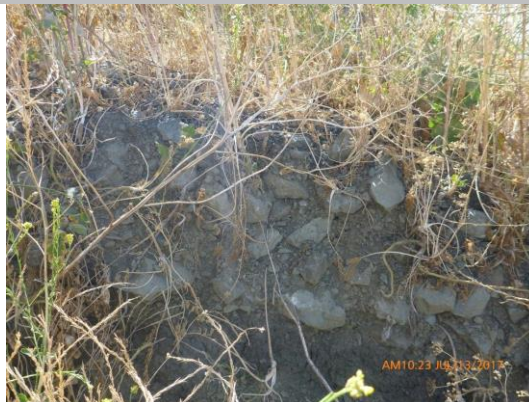
Photo 1 of 3 : SP_2018_RD2060_241_23_20180305_00035.jpg

LM Start	2.10	Rating **	A/W	Issue No.	23
LM End	2.13	Issue Type +	Ma	Location *	
Category	Supplemental			GPS Latitude/Longitude	
				Start	End
Item	2017 Storm Damage			38.259317 °	38.259258 °
				-121.726314 °	-121.726939 °
DWR ID	DWR_RD2060_01_f_2017_23				
Comment Code					
Inspector Comment					
Levee Evaluation Comments					
Description:Erosion commences approximately halfway down the water side slope extending to the rip rap.					
Site ID No:368					
Site Designation:LMA-195					
Repair Type: Erosion					
Rating:Serious					
Field Date:7/13/2017					
Notes: Erosion appears to be previously repaired, but has failed again.

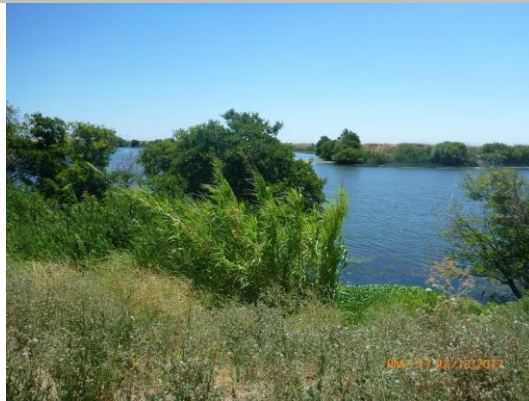
Photo 1 of 3 : SP_2018_RD2060_241_27_20180305_00047.jpg

LM Start	3.60	Rating **	M	Issue No.	27
LM End	3.61	Issue Type +	Ma	Location *	
Category	Supplemental			GPS Latitude/Longitude	
				Start	End
Item	2017 Storm Damage			38.261469 °	38.261464 °
				-121.748389 °	-121.748442 °
DWR ID	DWR_RD2060_01_f_2017_27				
Comment Code					
Inspector Comment					
Levee Evaluation Comments					
Description:Erosion commences halfway down the slope and extends to the toe. Erosion is concentrated at the water line.					
Site ID No:373					
Site Designation:LMA-200					
Repair Type: Erosion					
Rating:Area of Concern					
Field Date:7/13/2017					
Notes: Small erosion with a narrow deep cut. Heavy veg is protecting the slope.

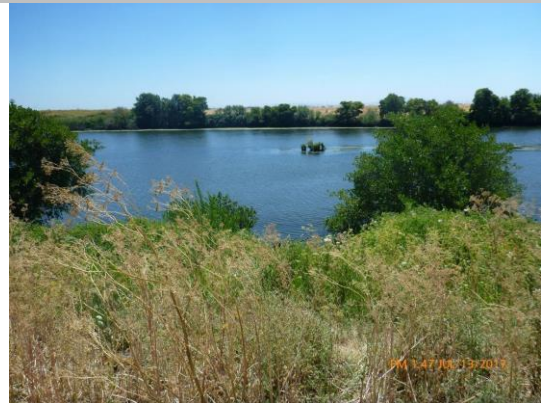
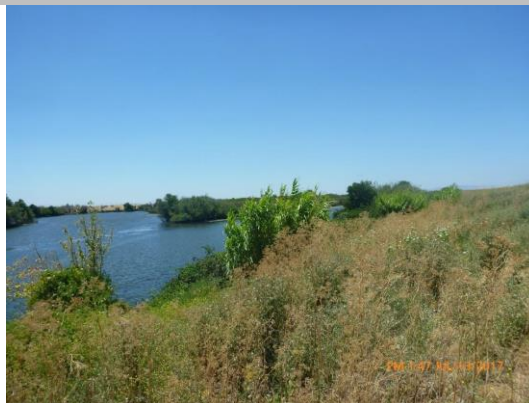
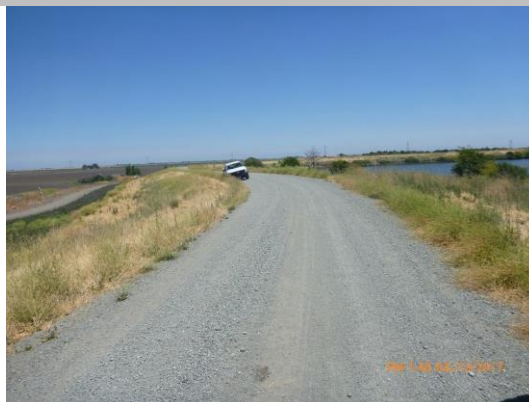
Photo 1 of 3 : SP_2018_RD2060_241_28_20180305_00050.jpg

LM Start	3.67	Rating **	M	Issue No.	28
LM End	3.67	Issue Type +	Ma	Location *	
Category	Supplemental			GPS Latitude/Longitude	
				Start	End
Item	2017 Storm Damage			38.261181 °	38.261167 °
				-121.749542 °	-121.749592 °
DWR ID	DWR_RD2060_01_f _ 2017_28				
Comment Code					
Inspector Comment					
Levee Evaluation Comments					
Description:Erosion is concentrated near the water line.					
Site ID No:374					
Site Designation:LMA-201					
Repair Type: Erosion					
Rating:Area of Concern					
Field Date:7/13/2017					
Notes: Small narrow and deep cut. May have been caused by a collapsed beaver den.

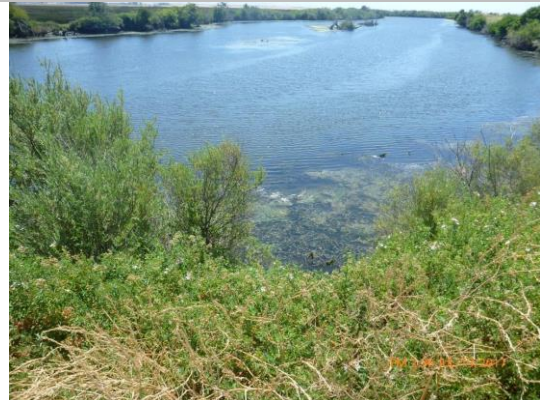
Photo 1 of 3 : SP_2018_RD2060_241_29_20180305_00053.jpg

LM Start	4.28	Rating **	A/W	Issue No.	29
LM End	4.28	Issue Type +	Ma	Location *	
Category	Supplemental			GPS Latitude/Longitude	
				Start	End
Item	2017 Storm Damage			38.260992 °	38.261017 °
				-121.759806 °	-121.759847 °
DWR ID	DWR_RD2060_01_f_2017_29				
Comment Code					
Inspector Comment					
Levee Evaluation Comments					
Description:Erosion commences halfway down the slope and extends to the toe. Erosion is concentrated at the water line.					
Site ID No:376					
Site Designation:LMA-203					
Repair Type: Erosion					
Rating:Area of Concern					
Field Date:7/13/2017					
Notes: Could not get to erosion due to dense veg. Possibly a deep narrow cut.

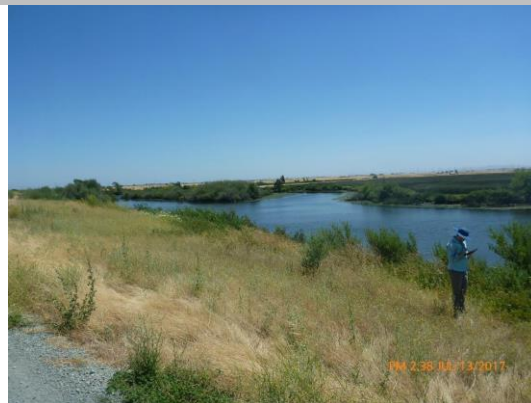
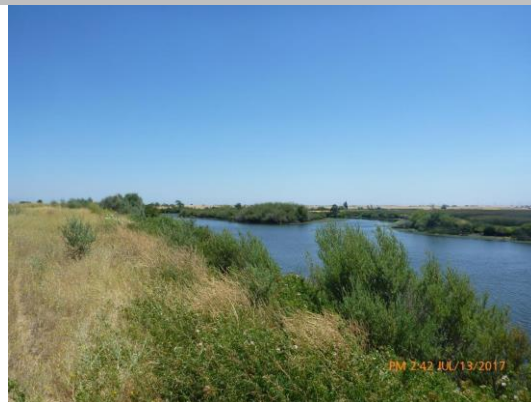
LM Start	4.28	Rating **	A/W	Issue No.	29 (cont)
LM End	4.28	Issue Type +	Ma	Location *	
Category	Supplemental			GPS Latitude/Longitude	
				Start	End
Item	2017 Storm Damage			38.260992 °	38.261017 °
				-121.759806 °	-121.759847 °
DWR ID	DWR_RD2060_01_f_2017_29				
Comment Code					
Inspector Comment					
Levee Evaluation Comments					
Description:Erosion commences halfway down the slope and extends to the toe. Erosion is concentrated at the water line.					
Site ID No:376					
Site Designation:LMA-203					
Repair Type: Erosion					
Rating:Area of Concern					
Field Date:7/13/2017					
Notes: Could not get to erosion due to dense veg. Possibly a deep narrow cut.

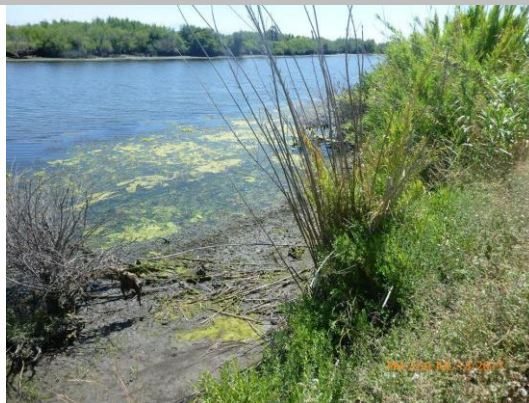
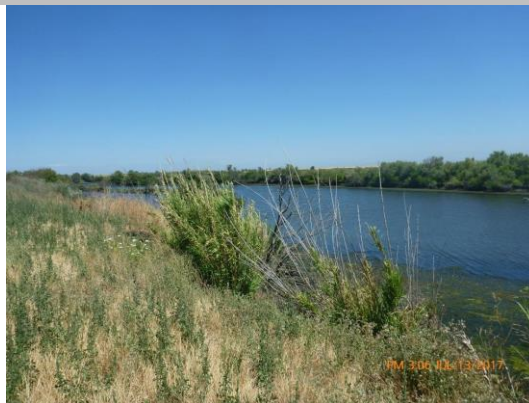
LM Start	4.40	Rating **	M	Issue No.	30
LM End	4.46	Issue Type +	Ma	Location *	
Category	Supplemental			GPS Latitude/Longitude	
				Start	End
Item	2017 Storm Damage			38.260850 °	38.260425 °
				-121.761875 °	-121.762861 °
DWR ID	DWR_RD2060_01_f_2017_30				
Comment Code					
Inspector Comment					
Levee Evaluation Comments					
Description:Erosion/sloughing commences approximately halfway down the slope. Erosion is concentrated mostly near the water line and has resulting in slippage of the slope.					
Site ID No:377					
Site Designation:LMA-204					
Repair Type: Erosion					
Rating:Area of Concern					
Field Date:7/13/2017					
Notes: large cut is 100' of 320' site. Large cut is 12' vertical and the rest is 6'.

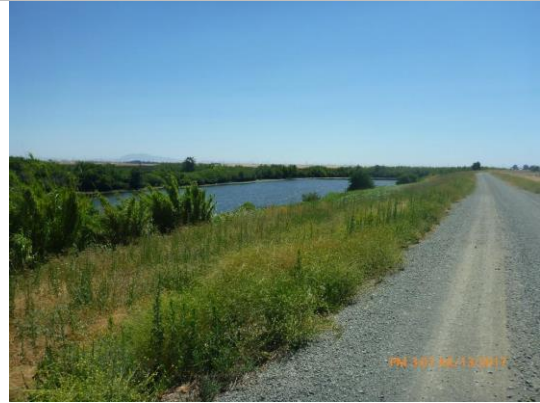
Photo 3 of 3 : SP_2018_RD2060_241_30_20180305_00058.jpg

LM Start	4.40	Rating **	M	Issue No.	30 (cont)	
LM End	4.46	Issue Type +	Ma	Location *		
Category	Supplemental			GPS Latitude/Longitude		
				Start	End	
Item	2017 Storm Damage			38.260850 °	38.260425 °	
				-121.761875 °	-121.762861 °	
DWR ID	DWR_RD2060_01_f_2017_30					
Comment Code						
Inspector Comment						
Levee Evaluation Comments Description:Erosion/sloughing commences approximately halfway down the slope. Erosion is concentrated mostly near the water line and has resulting in slippage of the slope. Site ID No:377 Site Designation:LMA-204 Repair Type: Erosion Rating:Area of Concern Field Date:7/13/2017 Notes: large cut is 100' of 320' site. Large cut is 12' vertical and the rest is 6'.

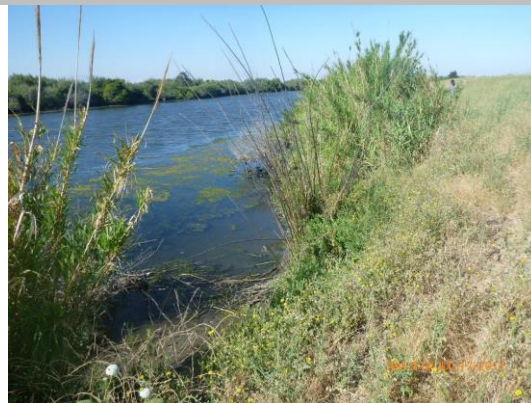
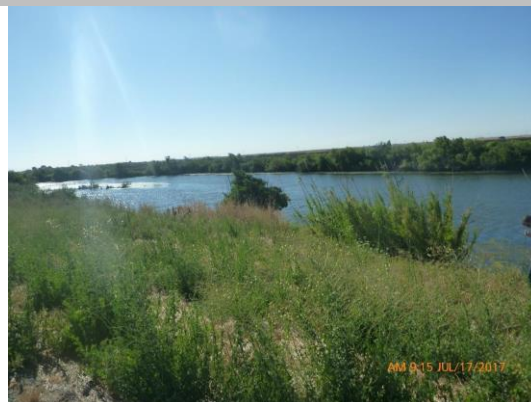
LM Start	4.50	Rating **	A/W	Issue No.	31
LM End	4.53	Issue Type +	Ma	Location *	
Category	Supplemental			GPS Latitude/Longitude	
				Start	End
Item	2017 Storm Damage			38.260150 °	38.259939 °
				-121.763556 °	-121.764064 °
DWR ID	DWR_RD2060_01_f_2017_31				
Comment Code					
Inspector Comment					
Levee Evaluation Comments					
Description:Erosion commences approximately 3/4 of the way down the slope. It has resulted in some sloughing.					
Site ID No:378					
Site Designation:LMA-205					
Repair Type: Erosion					
Rating:Serious					
Field Date:7/17/2017					
Notes: Deep, wide, vertical cut into slope almost 1/2 way into sope.

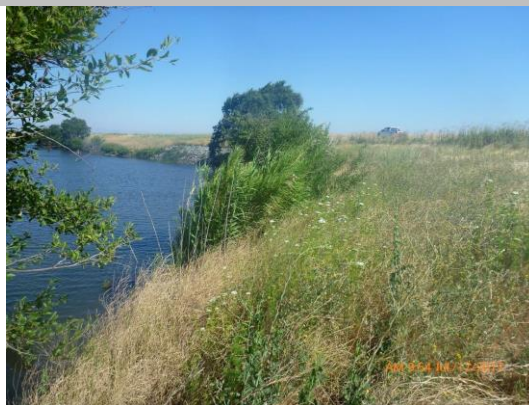
Photo 3 of 3 : SP_2018_RD2060_241_32_20180305_00064.jpg

LM Start	4.80	Rating **	A/W	Issue No.	32 (cont)	
LM End	4.88	Issue Type +	Ma	Location *		
Category	Supplemental			GPS Latitude/Longitude		
				Start	End	
Item	2017 Storm Damage			38.260714 °	38.261808 °	
				-121.767972 °	-121.768536 °	
DWR ID	DWR_RD2060_01_f_2017_32					
Comment Code						
Inspector Comment						
Levee Evaluation Comments						
Description:Erosion/sloughing commences approximately halfway down the slope. Erosion is concentrated mostly near the water line and has resulting in slippage of the slope towards the toe.						
Site ID No:379						
Site Designation:LMA-206						
Repair Type: Erosion						
Rating:Serious						
Field Date:7/17/2017						
Notes: Several erosions with slumping. Fresh soil indicates active erosion this season. Adjacent slope has riprap. Riprap should be extended along this stretch.

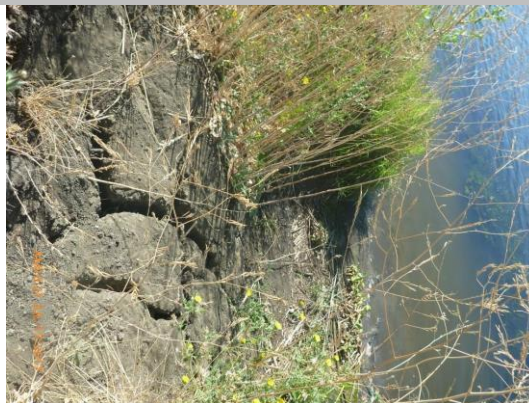
LM Start	4.92	Rating **	M	Issue No.	33
LM End	4.92	Issue Type +	Ma	Location *	
Category	Supplemental			GPS Latitude/Longitude	
				Start	End
Item	2017 Storm Damage			38.262128 °	38.262128 °
				-121.769175 °	-121.769175 °
DWR ID	DWR_RD2060_01_f_2017_33				
Comment Code					
Inspector Comment					
Levee Evaluation Comments					
Description:Erosion/sloughing commences approximately halfway down the slope. Erosion is concentrated mostly near the water line and has resulting in slippage of the slope into the toe.					
Site ID No:380					
Site Designation:LMA-207					
Repair Type: Erosion					
Rating:Area of Concern					
Field Date:7/17/2017					
Notes: Reduced length of site from 275 to 62. No widespread erosion, just 2 small erosions upstream from adjacent riprap.

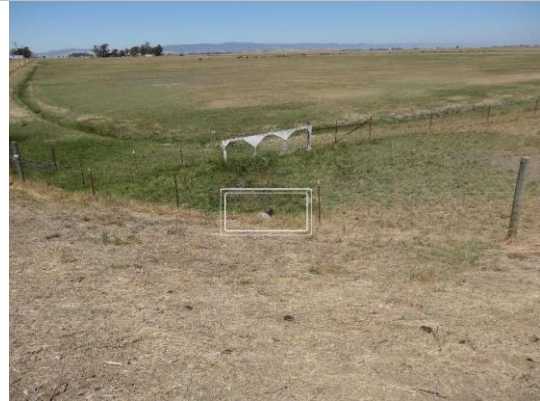
Photo 1 of 3 : UCIP_SP_2018_18386_30873.jpg

Comment Code						
Inspector Comment						
FS_ID:18386 DS_ID:22056 EP_NO: 10148 Repair Type: Non-Urgent Crossing Status: Found UCIP Comments: U-type concrete headwall on LS. Not accessible due to fence.Vegetation is partially blocking inlet & outlet pipe. FIELD_STRUCT_DESC: 24-inch corrugated metal gravity drainage pipe through the levee, 16 feet below the crown. Flap gate on the waterside (WS) end. Concrete U-shaped headwall on the landside (LS) end. Not accessible due to a fence. Vegetation is partially blocking the inlet and the outlet of the pipe. (24-inch drainage pipe through the levee and a flap gate retained under Automatic Board Order (ABO) issued as Permit No. 10148, 1974 - Reclamation District No. 2060, care of G. T. Wyatt). [Additional Reference(s): DWR Levee Log, 2005]. FS Date: 8/15/2013

WS view: overview of CMP from levee.

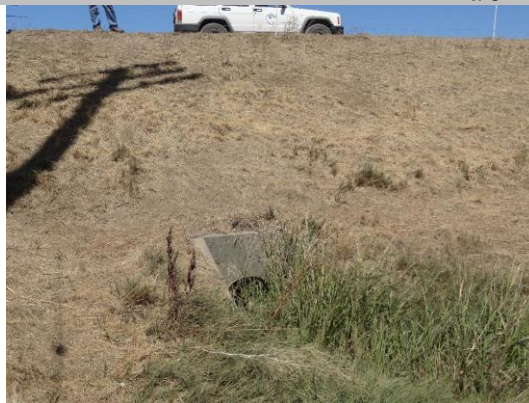
Photo 3 of 3 : UCIP_SP_2018_18386_30874.jpg

Comment Code						
Inspector Comment						
FS_ID:18386 DS_ID:22056 EP_NO: 10148 Repair Type: Non-Urgent Crossing Status: Found UCIP Comments: U-type concrete headwall on LS. Not accessible due to fence.Vegetation is partially blocking inlet & outlet pipe. FIELD_STRUCT_DESC: 24-inch corrugated metal gravity drainage pipe through the levee, 16 feet below the crown. Flap gate on the waterside (WS) end. Concrete U-shaped headwall on the landside (LS) end. Not accessible due to a fence. Vegetation is partially blocking the inlet and the outlet of the pipe. (24-inch drainage pipe through the levee and a flap gate retained under Automatic Board Order (ABO) issued as Permit No. 10148, 1974 - Reclamation District No. 2060, care of G. T. Wyatt). [Additional Reference(s): DWR Levee Log, 2005]. FS Date: 8/15/2013

LS view: CM pipe with U shaped concrete headwall. Not accessible.
Vegetation is partially blocking inlet pipe.

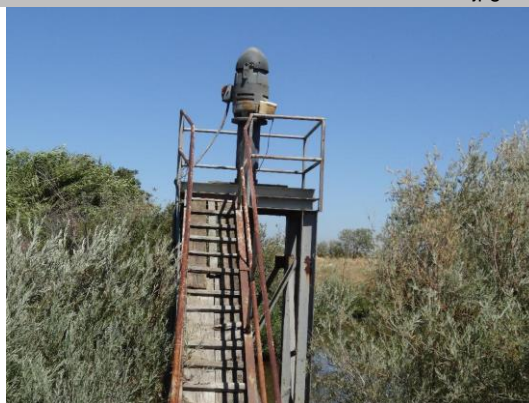
Photo 2 of 3 : UCIP_SP_2018_41668_31160.jpg

FS_ID:41668
DS_ID:22060
EP_NO: 5927
Repair Type: Non-Urgent
Crossing Status: Found
UCIP Comments: verify pipe has been abandoned properly. - abandoned pump and pipe.- electrical box on WS shoulder.
FIELD_STRUCT_DESC: *ABANDONED* 18-inch steel irrigation discharge pipe through the levee, 4 feet below the crown. Corrugated metal cutoff wall. Pump on a piling structure on the riverbank. Siphon breaker on the landside (LS) slope. Concrete distribution box and irrigation ditch at the LS toe. (To relocate an existing irrigation pumping plant and discharge pipe through the levee authorized under Permit No. 5927, 1967 - Cache Slough Pheasant Hunting Preserve, Inc., care of Downey, Brand, Seymour, and Rohwer, Attorneys at Law). [Additional Reference(s): DWR Levee Log, 2005].
FS Date: 8/15/2013

WS view: pump on pile structure with stairs on bank.

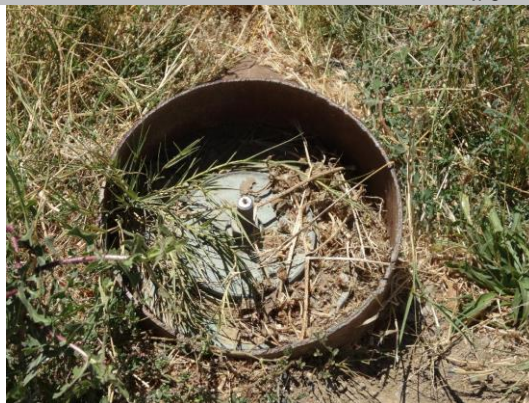
Photo 3 of 3 : UCIP_SP_2018_41668_31163.jpg

Comment Code						
Inspector Comment						
FS_ID:41668						
DS_ID:22060						
EP_NO: 5927						
Repair Type: Non-Urgent						
Crossing Status: Found						
UCIP Comments: verify pipe has been abandoned properly. - abandoned pump and pipe.- electrical box on WS shoulder.						
FIELD_STRUCT_DESC: *ABANDONED* 18-inch steel irrigation discharge pipe through the levee, 4 feet below the crown. Corrugated metal cutoff wall. Pump on a piling structure on the riverbank. Siphon breaker on the landside (LS) slope. Concrete distribution box and irrigation ditch at the LS toe. (To relocate an existing irrigation pumping plant and discharge pipe through the levee authorized under Permit No. 5927, 1967 - Cache Slough Pheasant Hunting Preserve, Inc., care of Downey, Brand, Seymour, and Rohwer, Attorneys at Law). [Additional Reference(s): DWR Levee Log, 2005].						
FS Date: 8/15/2013

LS view: obstructed siphon breaker in steel riser on levee slope.

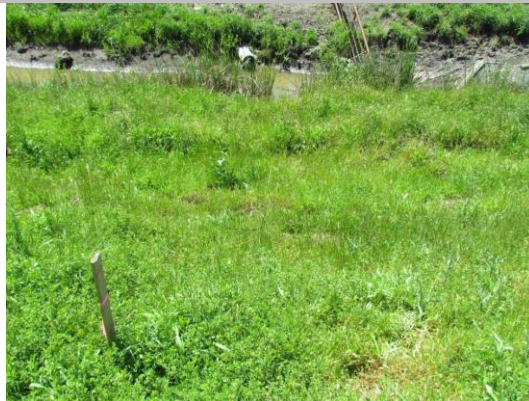
Photo 1 of 2 : SP_2018_RD2060_243_16_20180305_00016.jpg

LM Start	0.07	Rating **	M	Issue No.	16
LM End	0.07	Issue Type +	Ma	Location *	LS
Category	Earthen Levee			GPS Latitude/Longitude	
				Start	End
Item	Slope Stability			38.296350 °	38.296302 °
				-121.747642 °	-121.747565 °
DWR ID	DWR_RD2060_03_s_2017_16				
Comment Code					
S1 : Repair slope instability.					
Inspector Comment					
Sloughing on LS slope.

Looking down from the shoulder at the sloughing in the slope towards the irrigation ditch at toe.

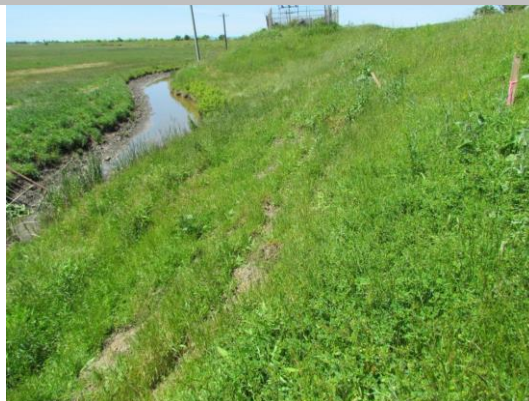
Photo 2 of 2 : SP_2018_RD2060_243_16_20180305_00017.jpg

Standing on the slope looking upstream at the slough.

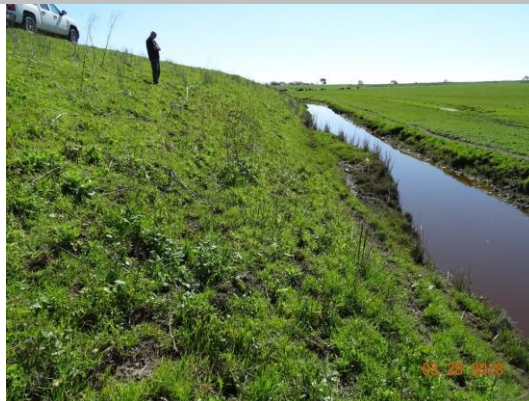
Photo 1 of 1 : SP_2018_RD2060_243_71_20180328_00171.jpg

LM Start	0.10	Rating **	A/W	Issue No.	71
LM End	0.10	Issue Type +	Ma	Location *	LS
Category	Earthen Levee			GPS Latitude/Longitude	
				Start	End
Item	Slope Stability			38.296084 °	38.296084 °
				-121.747052 °	-121.747052 °
DWR ID	DWR_RD2060_03_s_2018_71				
Comment Code					
S1 : Repair slope instability.					
Inspector Comment					
Minor slump at toe likely due to cattle should be repaired.

Lower landside slope has slumped into ditch. Should be repaired.

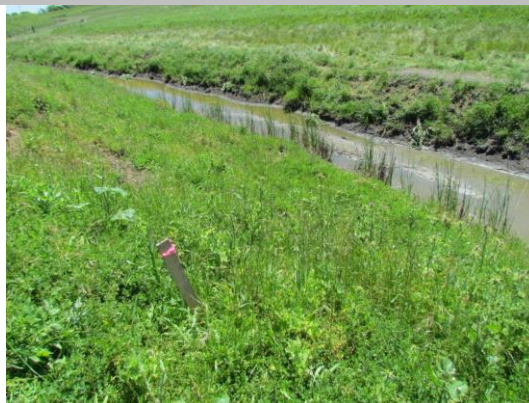
Photo 2 of 2 : SP_2018_RD2060_243_19_20180305_00024.jpg

LM Start	0.15	Rating **	A/W	Issue No.	19 (cont)	
LM End	0.19	Issue Type +	Ma	Location *	LS	
Category	Earthen Levee			GPS Latitude/Longitude		
				Start		End
Item	Slope Stability			38.295738 °		38.295559 °
				-121.746293 °		-121.745583 °
DWR ID	DWR_RD2060_03_s_2017_19					
Comment Code						
S1 : Repair slope instability.						
Inspector Comment						
There are several signs of sloughing occurring on the slope notices after the flood event Feb. 2017 storm. 10/11/17: This issue's rating has been changed from U to A/W in consideration of the DWR 2017 Levee Evaluation Storm Site entry.

Just upstream of the erosion site looking downstream from the landside slope.

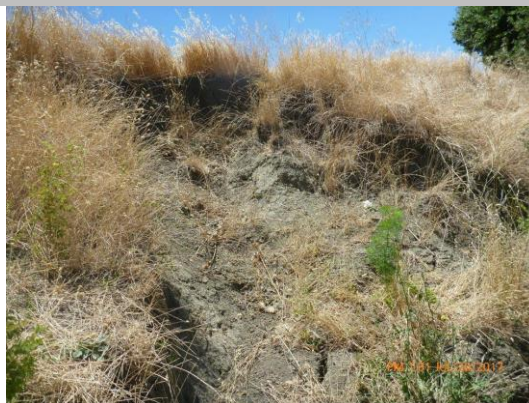
Photo 1 of 3 : SP_2018_RD2060_243_14_20180305_00013.jpg

LM Start	0.64	Rating **	M	Issue No.	14
LM End	0.64	Issue Type +	Ma	Location *	
Category	Supplemental			GPS Latitude/Longitude	
				Start	End
Item	2017 Storm Damage			38.292197 °	38.292208 °
				-121.739661 °	-121.739611 °
DWR ID	DWR_RD2060_03_f_2017_14				
Comment Code					
Inspector Comment					
Levee Evaluation Comments					
Description:Erosion commences near the edge of the crown and extends down the slope. Erosion has resulted in slippage into the waterside toe.					
Site ID No:386					
Site Designation:LMA-213					
Repair Type: Erosion					
Rating:Area of Concern					
Field Date:7/20/2017					
Notes:

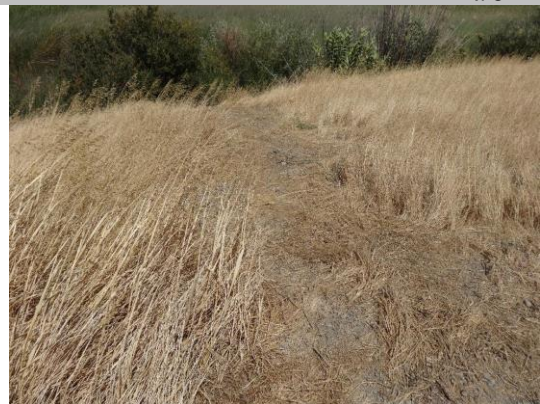
Photo 1 of 2 : UCIP_SP_2018_18727_31317.jpg

LM Start	0.90	Rating **	M	Issue No.	72
LM End	0.90	Issue Type +	En	Location *	
Category	Supplemental		GPS Latitude/Longitude		
			Start	End	
Item	DWR UCIP Field Study		38.290684 °	38.290684 °	
			-121.735668 °	-121.735668 °	
DWR ID					
Comment Code					
Inspector Comment					
FS_ID: 18727 DS_ID: 22067 EP_NO: N/A Repair Type: Non-Urgent Crossing Status: Found UCIP Comments: Seem abandoned. Not found- pump on LS. Needs more exploration. FIELD_STRUCT_DESC: 6-inch steel irrigation discharge pipe through the levee, 2.8 feet below the crown. Pump on the landside (LS). Gate valve on the waterside (WS). [Additional Reference(s): USACE Sacramento O&M Manual 107, April 1959, (HLM 0.4), 10-inch pipe referenced]. FS Date: 8/15/2013

Waterside view: levee slope.

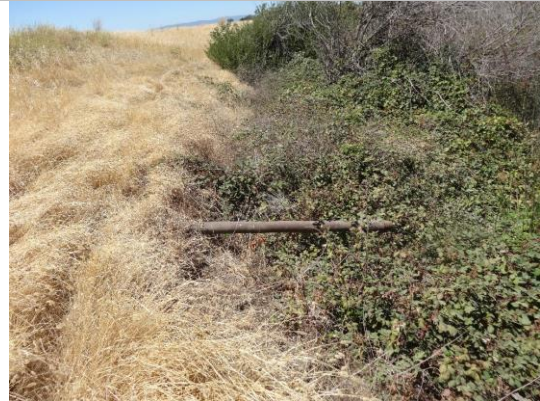
Photo 2 of 2 : UCIP_SP_2018_18727_31316.jpg

LM Start	0.90	Rating **	M	Issue No.	72 (cont)
LM End	0.90	Issue Type +	En	Location *	
Category	Supplemental			GPS Latitude/Longitude	
				Start	End
Item	DWR UCIP Field Study			38.290684 °	38.290684 °
				-121.735668 °	-121.735668 °
DWR ID					
Comment Code					
Inspector Comment					
FS_ID:18727 DS_ID:22067 EP_NO: N/A Repair Type: Non-Urgent Crossing Status: Found UCIP Comments: Seem abandoned.Not found- pump on LS. Needs more exploration. FIELD_STRUCT_DESC: 6-inch steel irrigation discharge pipe through the levee, 2.8 feet below the crown. Pump on the landside (LS). Gate valve on the waterside (WS). [Additional Reference(s): USACE Sacramento O&M Manual 107, April 1959, (HLM 0.4), 10-inch pipe referenced]. FS Date: 8/15/2013

Waterside view: levee slope and a steel pipe.

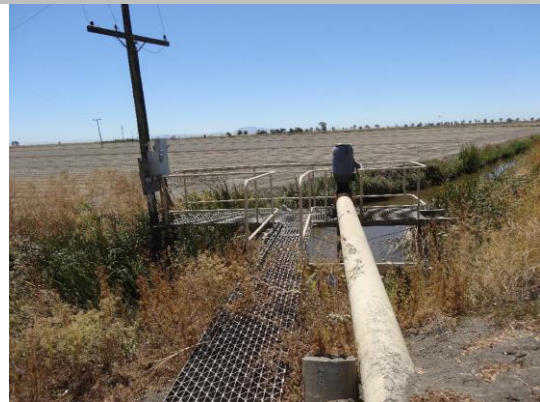
Photo 1 of 3 : UCIP_SP_2018_18726_31314.jpg

Comment Code					
Inspector Comment					
FS_ID:18726 DS_ID:22063 EP_NO: 6342 Repair Type: Non-Urgent Crossing Status: Found UCIP Comments: Leaky siphon breaker may need to be repaired. Dense vegetation on WS.Not found- gate valve on LS. FIELD_STRUCT_DESC: 16-inch coated steel drainage discharge pipe through the levee, 8 feet below the crown. Vertical pump in drainage ditch on the landside (LS). Gate valve on the LS. Siphon breaker on the waterside (WS). (Plans to replace a 10-inch drainage pipe through the levee authorized under Permit No. 6342, 1968 - Hastings Farms. Plans to revise plans by changing pipe size from 10-inch to 16-inch through the levee authorized under Permit No. 6342-A, 1971 - Hastings Farms). FS Date: 8/15/2013

Landside view: pump, service pole, steel support structure, walkway, and pipe.

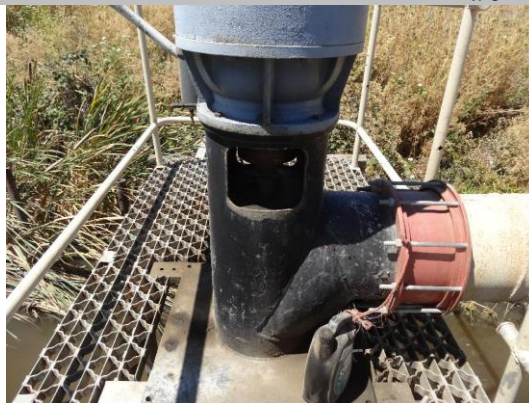
Photo 2 of 3 : UCIP_SP_2018_18726_31313.jpg

Comment Code						
Inspector Comment						
FS_ID:18726 DS_ID:22063 EP_NO: 6342 Repair Type: Non-Urgent Crossing Status: Found UCIP Comments: Leaky siphon breaker may need to be repaired. Dense vegetation on WS.Not found- gate valve on LS. FIELD_STRUCT_DESC: 16-inch coated steel drainage discharge pipe through the levee, 8 feet below the crown. Vertical pump in drainage ditch on the landside (LS). Gate valve on the LS. Siphon breaker on the waterside (WS). (Plans to replace a 10-inch drainage pipe through the levee authorized under Permit No. 6342, 1968 - Hastings Farms. Plans to revise plans by changing pipe size from 10-inch to 16-inch through the levee authorized under Permit No. 6342-A, 1971 - Hastings Farms). FS Date: 8/15/2013

Landside view: pipe and pump on steel structure in drain ditch.

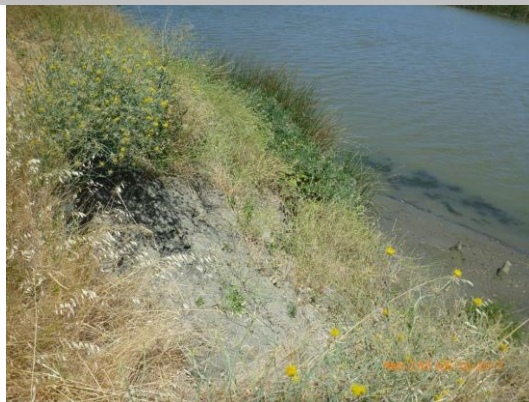
LM Start	1.12	Rating **	A/W	Issue No.	17
LM End	1.13	Issue Type +	Ma	Location *	
Category	Supplemental			GPS Latitude/Longitude	
				Start	End
Item	2017 Storm Damage			38.290539 °	38.290544 °
				-121.731603 °	-121.731494 °
DWR ID	DWR_RD2060_03_f_2017_17				
Comment Code					
Inspector Comment					
Levee Evaluation Comments					
Description:Erosion commences near the crown and has resulted in					
slippage into the waterside toe.					
Site ID No:389					
Site Designation:LMA-216					
Repair Type: Erosion					
Rating:Critical					
Field Date:7/20/2017					
Notes: Vertical section sloughing halfway down WS slope. Continued					
erosion down WS slope. Recommemd repair before next high water.

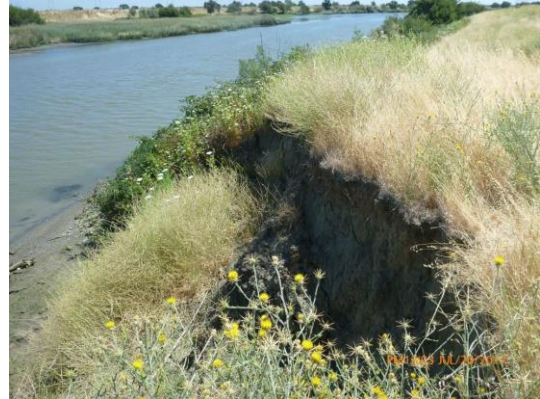
Photo 3 of 3 : SP_2018_RD2060_243_17_20180305_00020.jpg

LM Start	1.12	Rating **	A/W	Issue No.	17 (cont)	
LM End	1.13	Issue Type +	Ma	Location *		
Category	Supplemental			GPS Latitude/Longitude		
				Start	End	
Item	2017 Storm Damage			38.290539 °	38.290544 °	
				-121.731603 °	-121.731494 °	
DWR ID	DWR_RD2060_03_f_2017_17					
Comment Code						
Inspector Comment						
Levee Evaluation Comments						
Description:Erosion commences near the crown and has resulted in						
slippage into the waterside toe.						
Site ID No:389						
Site Designation:LMA-216						
Repair Type: Erosion						
Rating:Critical						
Field Date:7/20/2017						
Notes: Vertical section sloughing halfway down WS slope. Continued						
erosion down WS slope. Recommemd repair before next high water.

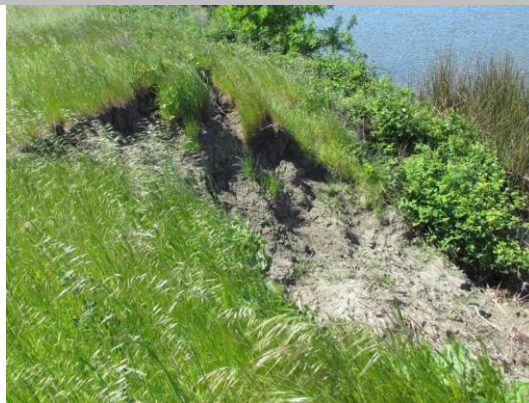
Photo 2 of 2 : SP_2018_RD2060_243_18_20180305_00022.jpg

LM Start	1.12	Rating **	A/W	Issue No.	18 (cont)	
LM End	1.12	Issue Type +	Ma	Location *	WS	
Category	Earthen Levee			GPS Latitude/Longitude		
				Start		End
Item	Slope Stability			38.290558 °		38.290558 °
				-121.731580 °		-121.731580 °
DWR ID	DWR_RD2060_03_s_2017_18					
Comment Code						
S1 : Repair slope instability.						
Inspector Comment						
The District has scheduled repairs of this site. 10/11/17: This issue's rating has been changed from U to A/W in consideration of the DWR 2017 Levee Evaluation Storm Site entry.

Looking upstream at the erosion on the waterside slope.

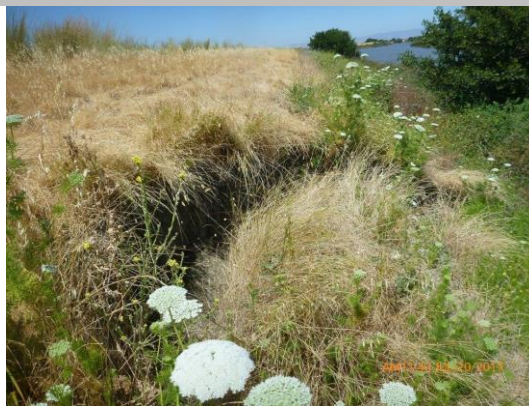
Photo 1 of 3 : SP_2018_RD2060_243_20_20180305_00025.jpg

LM Start	1.21	Rating **	M	Issue No.	20
LM End	1.23	Issue Type +	Ma	Location *	
Category	Supplemental			GPS Latitude/Longitude	
				Start	End
Item	2017 Storm Damage			38.290511 °	38.290486 °
				-121.729867 °	-121.729603 °
DWR ID	DWR_RD2060_03_f _ 2017_20				
Comment Code					
Inspector Comment					
Levee Evaluation Comments					
Description:Erosion commences 1/4 of the way down the slope with slippage towards the water side toe.					
Site ID No:390					
Site Designation:LMA-217					
Repair Type: Erosion					
Rating:Area of Concern					
Field Date:7/20/2017					
Notes: Erosion halfway down WS slope. Monitor for progression.

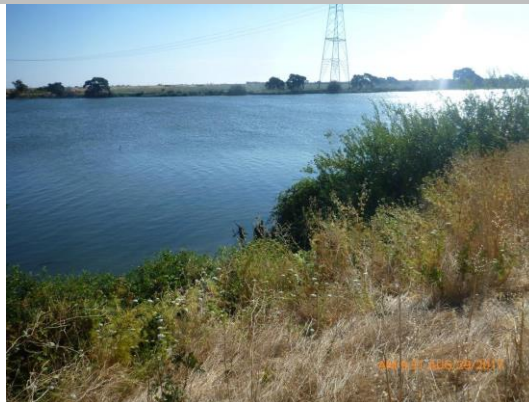
LM Start	1.38	Rating **	M	Issue No.	21	
LM End	1.42	Issue Type +	Ma	Location *		
Category	Supplemental			GPS Latitude/Longitude		
				Start	End	
Item	2017 Storm Damage			38.290067 °	38.289608 °	
				-121.726839 °	-121.726344 °	
DWR ID	DWR_RD2060_03_f_2017_21					
Comment Code						
Inspector Comment						
Levee Evaluation Comments Description:MBK Delta Erosion Sites_6-29-2017 Site ID No:482 Site Designation:LMA-320 Repair Type: Erosion Rating:Area of Concern Field Date:8/29/2017 Notes:

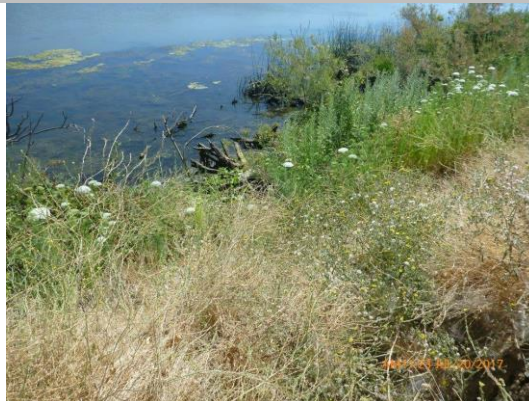
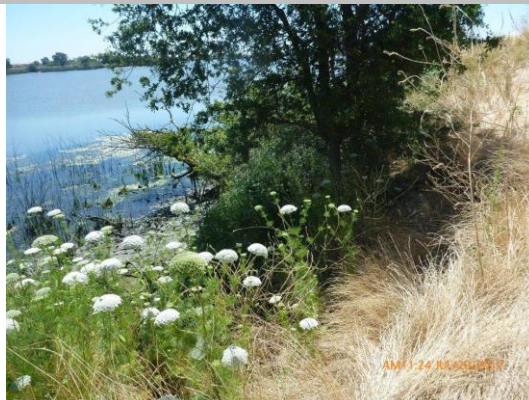
LM Start	1.45	Rating **	M	Issue No.	22 (cont)	
LM End	1.59	Issue Type +	Ma	Location *		
Category	Supplemental			GPS Latitude/Longitude		
				Start	End	
Item	2017 Storm Damage			38.289256 °	38.287689 °	
				-121.726050 °	-121.724658 °	
DWR ID	DWR_RD2060_03_f _ 2017_22					
Comment Code						
Inspector Comment						
Levee Evaluation Comments						
Description:Erosion commences halfway down the slope and results in						
slippage into the waterside toe.						
Site ID No:392						
Site Designation:LMA-219						
Repair Type: Erosion						
Rating:Area of Concern						
Field Date:7/20/2017						
Notes: Moderate erosion present on WS slope. Monitor for progression.

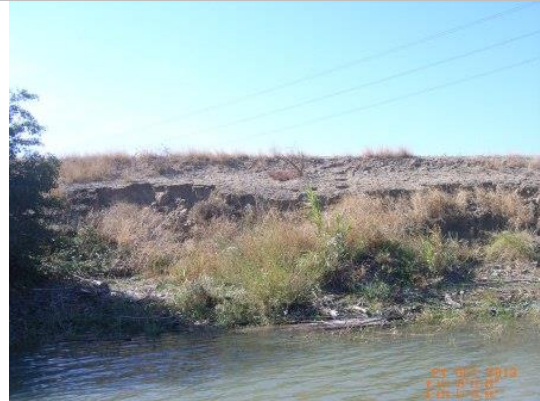
Photo 1 of 1 : SP_2018_RD2060_243_8_20180305_00008.jpg

LM Start	1.52	Rating **	A/W	Issue No.	8
LM End	1.74	Issue Type +	Ma	Location *	WS
Category	Supplemental			GPS Latitude/Longitude	
				Start	End
Item	2015 USACE Erosion Survey, DRAFT			38.288598 °	38.286051 °
				-121.725184 °	-121.722818 °
DWR ID	DWR_RD2060_03_s_2016_8				
Comment Code					
Inspector Comment					
Site added in 1997 and removed in 2003. 2005 - Put back in the inventory. 2006 - Stone repair at the middle of the site. 2011 - Some rock place at toe in the past year. 2013 - Site extended both upstream and downstream to include new erosion pockets. 2015: No observed changes. [2015 Site ID: CHS_23-6_R]

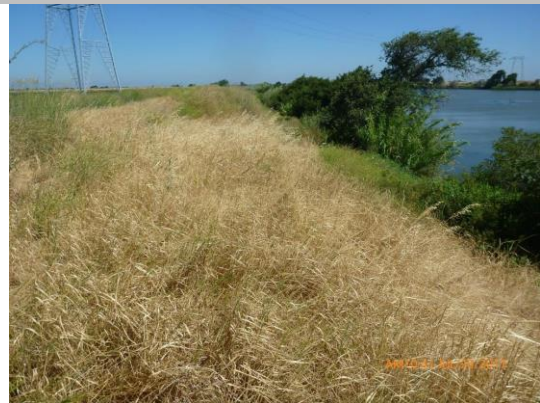
Photo 1 of 3 : SP_2018_RD2060_243_23_20180305_00034.jpg

LM Start	1.62	Rating **	A/W	Issue No.	23
LM End	1.63	Issue Type +	Ma	Location *	
Category	Supplemental			GPS Latitude/Longitude	
				Start	End
Item	2017 Storm Damage			38.287336 °	38.287222 °
				-121.724364 °	-121.724253 °
DWR ID	DWR_RD2060_03_f_2017_23				
Comment Code					
Inspector Comment					
Levee Evaluation Comments					
Description:Erosion commences halfway down the slope and results in slippage into the waterside toe. Existing rip rap has sloughed into the water side toe.					
Site ID No:393					
Site Designation:LMA-220					
Repair Type: Erosion					
Rating:Serious					
Field Date:7/20/2017					
Notes: Moderate sloughing 8ft from WS crown. Erosion at high water mark.

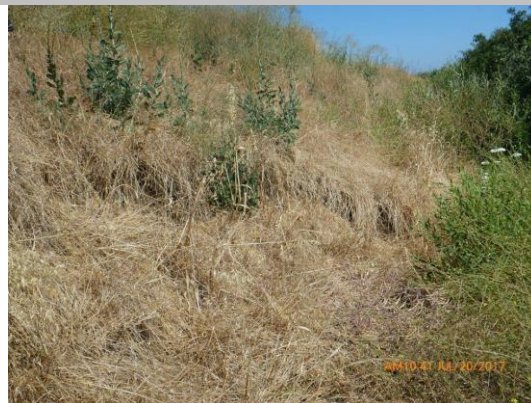
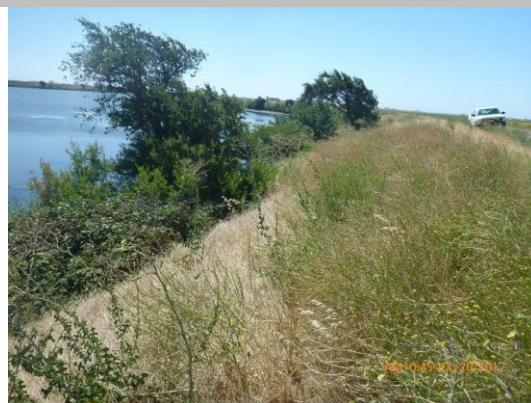
LM Start	1.62	Rating **	A/W	Issue No.	23 (cont)	
LM End	1.63	Issue Type +	Ma	Location *		
Category	Supplemental			GPS Latitude/Longitude		
				Start	End	
Item	2017 Storm Damage			38.287336 °	38.287222 °	
				-121.724364 °	-121.724253 °	
DWR ID	DWR_RD2060_03_f_2017_23					
Comment Code						
Inspector Comment						
Levee Evaluation Comments						
Description:Erosion commences halfway down the slope and results in						
slippage into the waterside toe. Existing rip rap has sloughed into the						
water side toe.						
Site ID No:393						
Site Designation:LMA-220						
Repair Type: Erosion						
Rating:Serious						
Field Date:7/20/2017						
Notes: Moderate sloughing 8ft from WS crown. Erosion at high water						
mark.

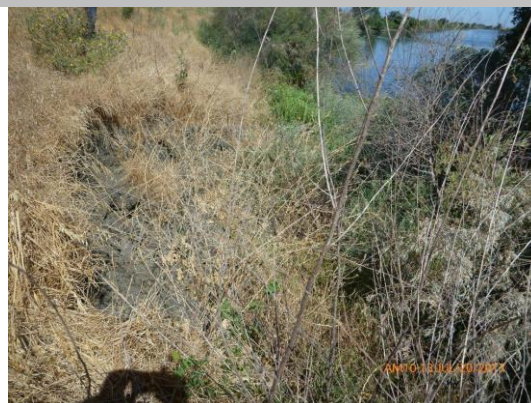
Photo 1 of 3 : SP_2018_RD2060_243_25_20180305_00037.jpg

LM Start	1.84	Rating **	M	Issue No.	25
LM End	1.92	Issue Type +	Ma	Location *	
Category	Supplemental		GPS Latitude/Longitude		
			Start	End	
Item	2017 Storm Damage		38.284825 °	38.284467 °	
			-121.721764 °	-121.720339 °	
DWR ID	DWR_RD2060_03_f_2017_25				
Comment Code					
Inspector Comment					
Levee Evaluation Comments Description: Erosion commences halfway down the slope and results in slippage into the waterside toe. Site ID No: 395 Site Designation: LMA-222 Repair Type: Erosion Rating: Area of Concern Field Date: 7/20/2017 Notes: Erosion halfway down slope. Monitor for progression.

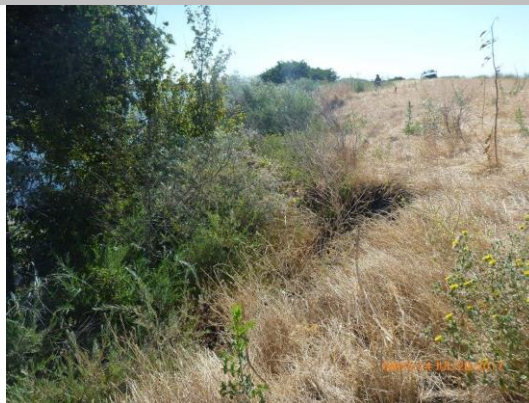
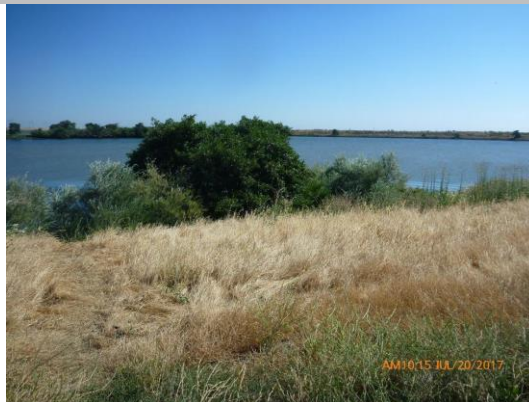
LM Start	1.84	Rating **	M	Issue No.	25 (cont)	
LM End	1.92	Issue Type +	Ma	Location *		
Category	Supplemental			GPS Latitude/Longitude		
				Start	End	
Item	2017 Storm Damage			38.284825 °	38.284467 °	
				-121.721764 °	-121.720339 °	
DWR ID	DWR_RD2060_03_f_2017_25					
Comment Code						
Inspector Comment						
Levee Evaluation Comments						
Description:Erosion commences halfway down the slope and results in						
slippage into the waterside toe.						
Site ID No:395						
Site Designation:LMA-222						
Repair Type: Erosion						
Rating:Area of Concern						
Field Date:7/20/2017						
Notes: Erosion halfway down slope. Monitor for progression.

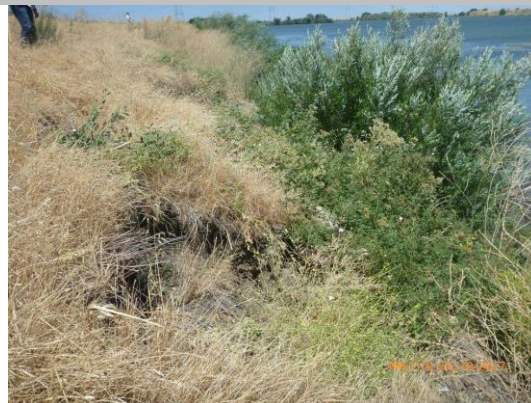
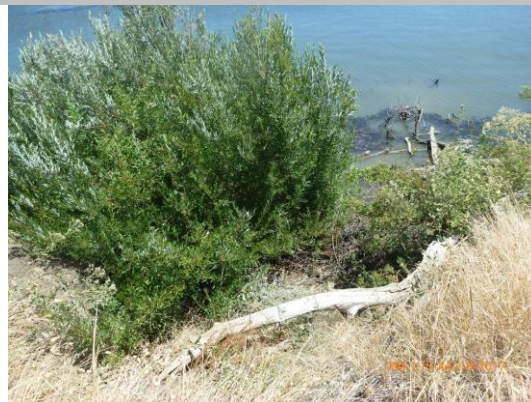
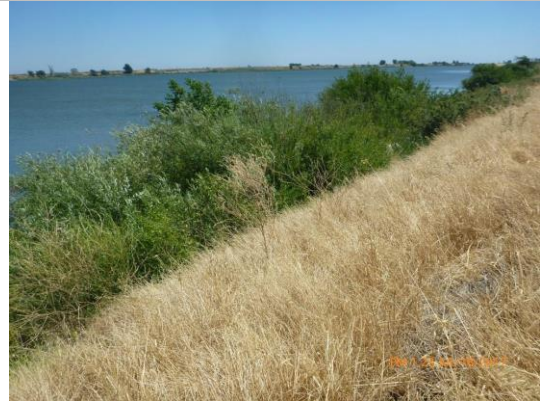
LM Start	2.12	Rating **	A/W	Issue No.	27
LM End	2.15	Issue Type +	Ma	Location *	
Category	Supplemental			GPS Latitude/Longitude	
				Start	End
Item	2017 Storm Damage			38.282733 °	38.282403 °
				-121.717683 °	-121.717428 °
DWR ID	DWR_RD2060_03_f_2017_27				
Comment Code					
Inspector Comment					
Levee Evaluation Comments Description:Erosion commences approximately 1/4 of the way down the slope and results in slippage into the waterside toe. Site ID No:397 Site Designation:LMA-224 Repair Type: Erosion Rating:Serious Field Date:7/18/2017 Notes: Benched erosion with large cracks on slope above. Light veg in erosion.

LM Start	2.12	Rating **	A/W	Issue No.	27 (cont)	
LM End	2.15	Issue Type +	Ma	Location *		
Category	Supplemental			GPS Latitude/Longitude		
				Start	End	
Item	2017 Storm Damage			38.282733 °	38.282403 °	
				-121.717683 °	-121.717428 °	
DWR ID	DWR_RD2060_03_f_2017_27					
Comment Code						
Inspector Comment						
Levee Evaluation Comments						
Description:Erosion commences approximately 1/4 of the way down the slope and results in slippage into the waterside toe.						
Site ID No:397						
Site Designation:LMA-224						
Repair Type: Erosion						
Rating:Serious						
Field Date:7/18/2017						
Notes: Benched erosion with large cracks on slope above. Light veg in erosion.

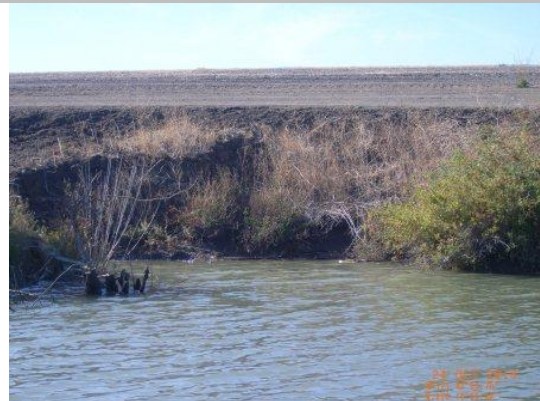
Photo 1 of 1 : SP_2018_RD2060_243_7_20180305_00007.jpg

LM Start	2.18	Rating **	A/W	Issue No.	7
LM End	2.23	Issue Type +	Ma	Location *	WS
Category	Supplemental			GPS Latitude/Longitude	
				Start	End
Item	2015 USACE Erosion Survey, DRAFT			38.282100 °	38.281510 °
				-121.716817 °	-121.716319 °
DWR ID	DWR_RD2060_03_s_2016_7				
Comment Code					
Inspector Comment					
2007 - Geotechnical failure of midside slope and wave wash/scalloping in toe area. Stone revetment upstream and downstream of site. Similar sites are present all along the right bank downstream of this site, most could be repaired with some maintenance. 2010 - Minor new erosion. 2015: No observed changes. [2015 Site ID: CHS_22-8_R]

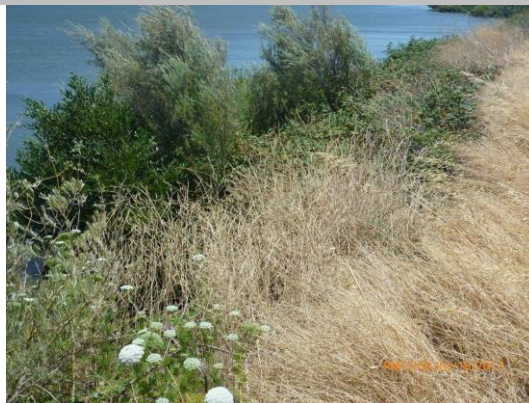
Photo 3 of 3 : SP_2018_RD2060_243_28_20180305_00048.jpg

LM Start	2.19	Rating **	A/W	Issue No.	28 (cont)
LM End	2.22	Issue Type +	Ma	Location *	
Category	Supplemental			GPS Latitude/Longitude	
				Start	End
Item	2017 Storm Damage			38.281839 °	38.281486 °
				-121.716964 °	-121.716661 °
DWR ID	DWR_RD2060_03_f_2017_28				
Comment Code					
Inspector Comment					
Levee Evaluation Comments					
Description:Erosion commences approximately 1/4 of the way down the slope and results in slippage into the waterside toe.					
Site ID No:398					
Site Designation:LMA-225					
Repair Type: Erosion					
Rating:Serious					
Field Date:7/18/2017					
Notes: Erosion is near vertical with light veg. Existing rip rap to the left of site.
